UI Bulletin #186

Subject:	Fluid Leak in the Center of Vehicle on Drivers Side, Tapping/Knocking Noise on Turns
Models Years Affected:	2018 - 2019
Models Affected:	Chevrolet Express, GMC Savana Cut-away models
Origination Date:	April 8, 2022
Revision Date:	N/A

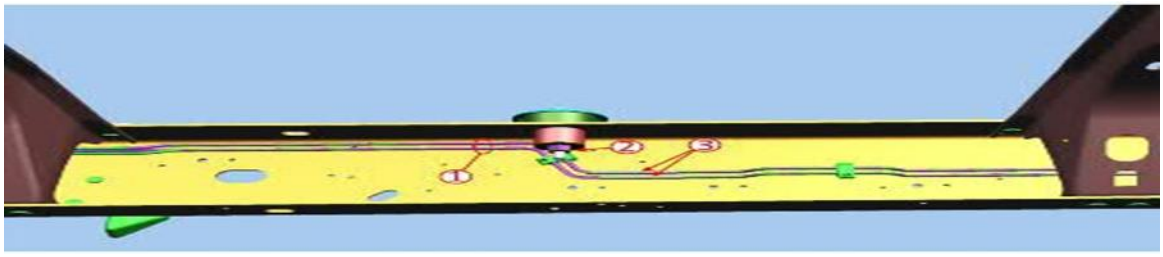
Some technicians may find during vehicle inspection the rear brake lines coming into contact with the center body mount.

This condition may be caused by the rear brake lines coming into contact with the body mount.

1. Verify in the brake lines (1) are contacting the body mount (2).
2. Remove the brake pipe protective sleeves (3) and set aside.
3. From the bulk brake line, cut approximately 24 inches (61 cm) off.

4. Using a pipe bender or equivalent, bend the tubing so that it matches the old tubing.
